TS-AMD-85741
October 1985

HISTORICAL AERIAL PHOTOGRAPHIC ANALYSIS OF WOOD TREATMENT FACILITIES

Montana

W. M. Mack
Environmental Programs
Lockheed Engineering and Management Services Company, Inc.
Las Vegas, Nevada 89114

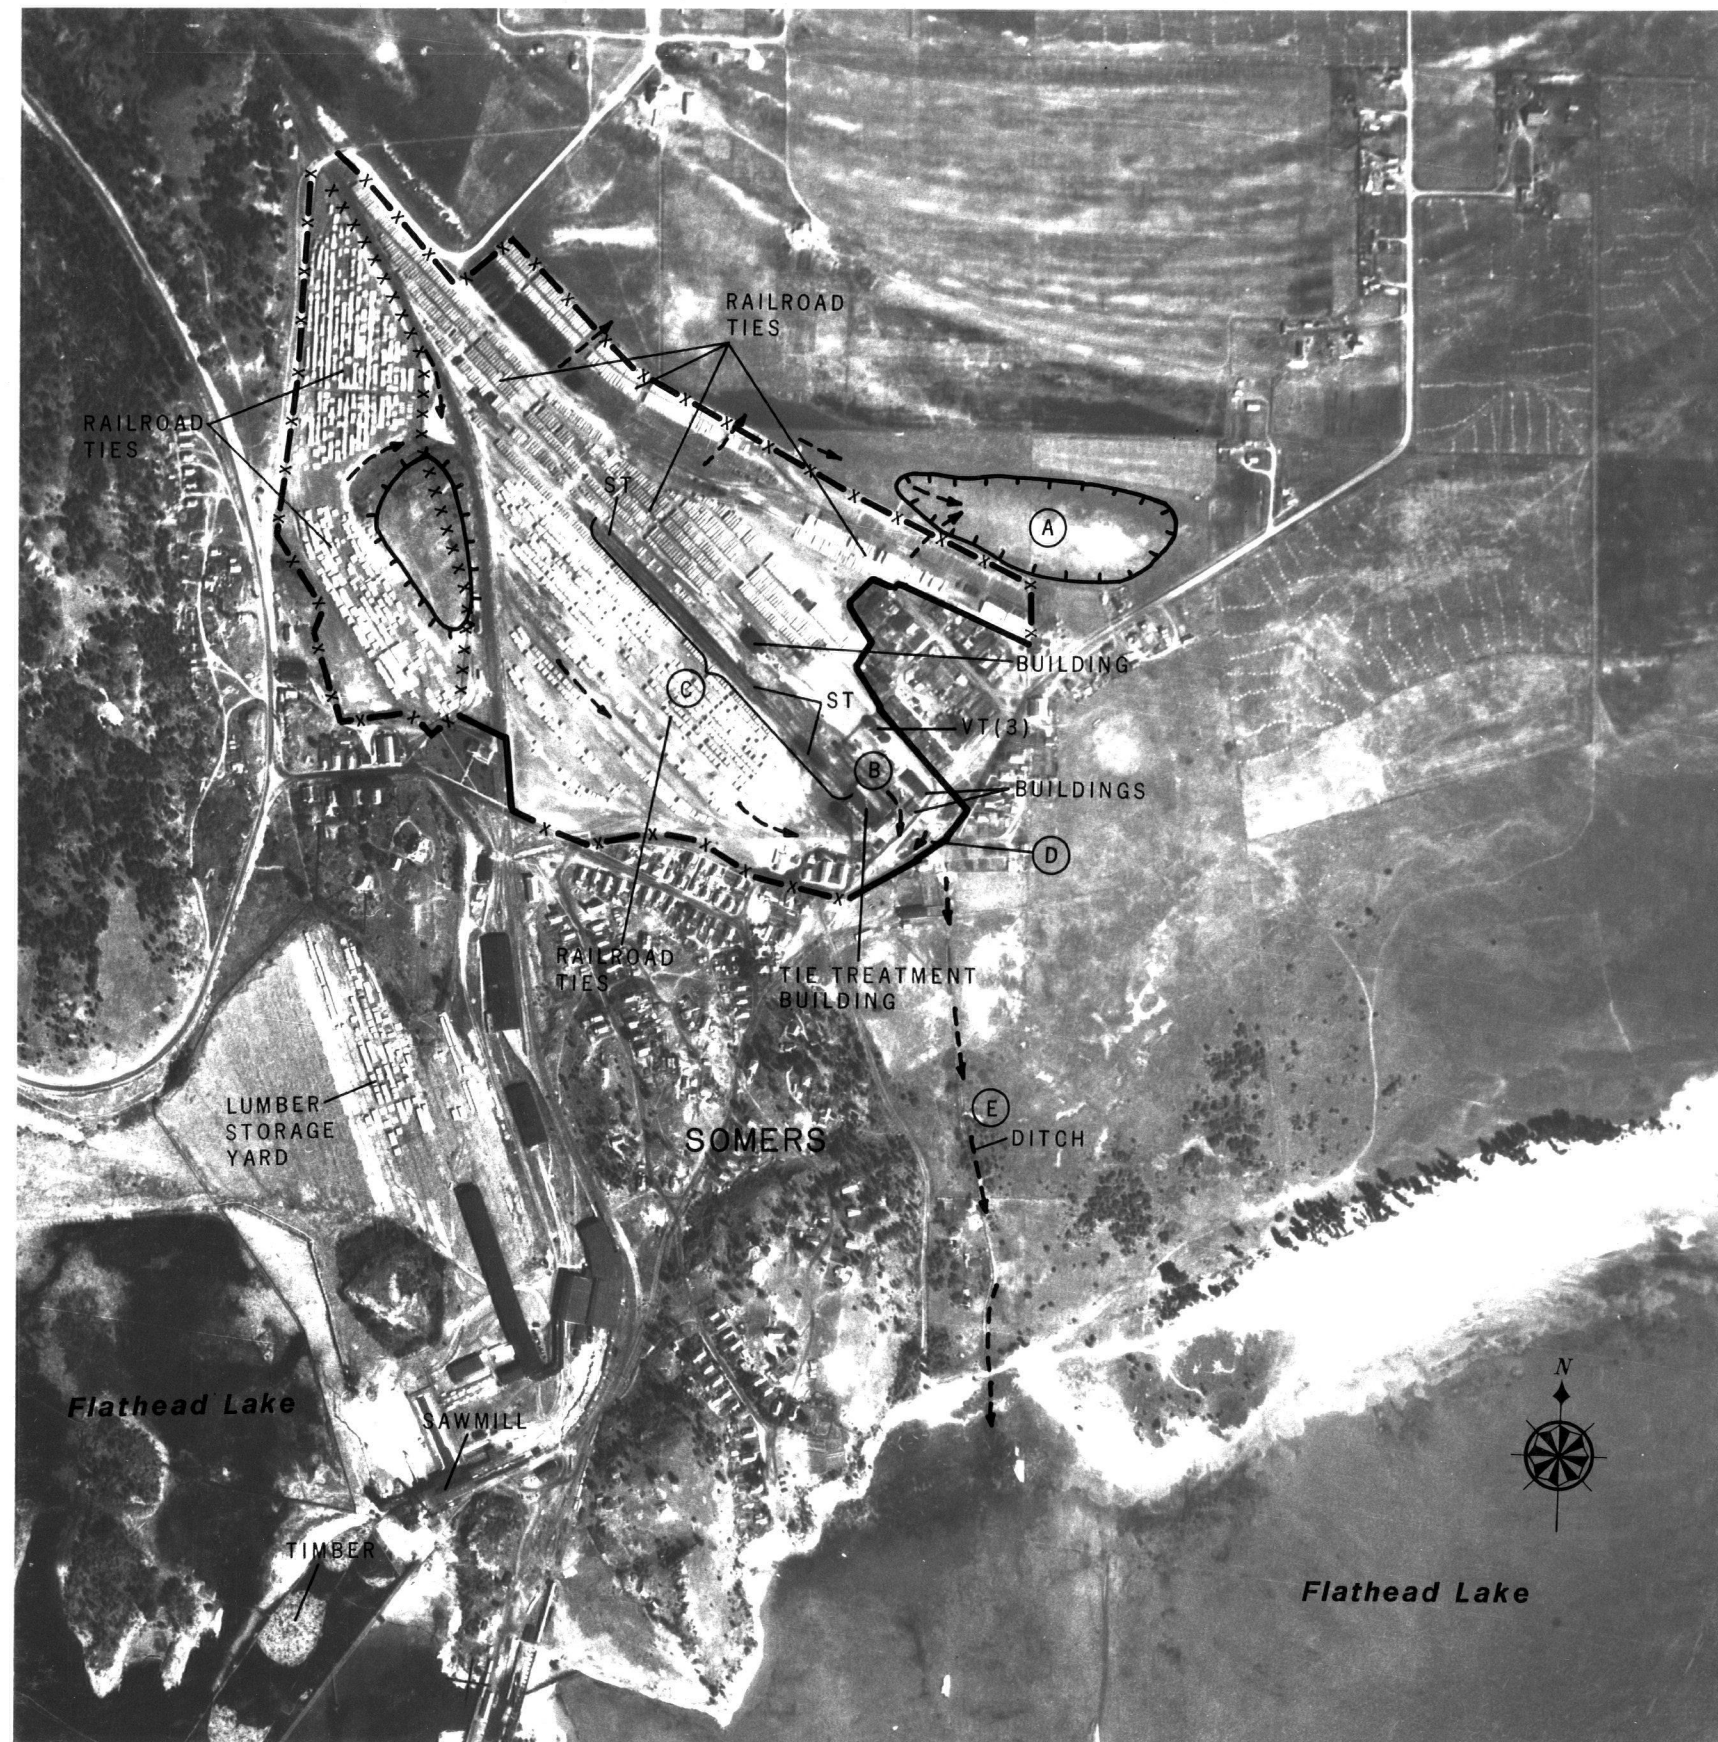
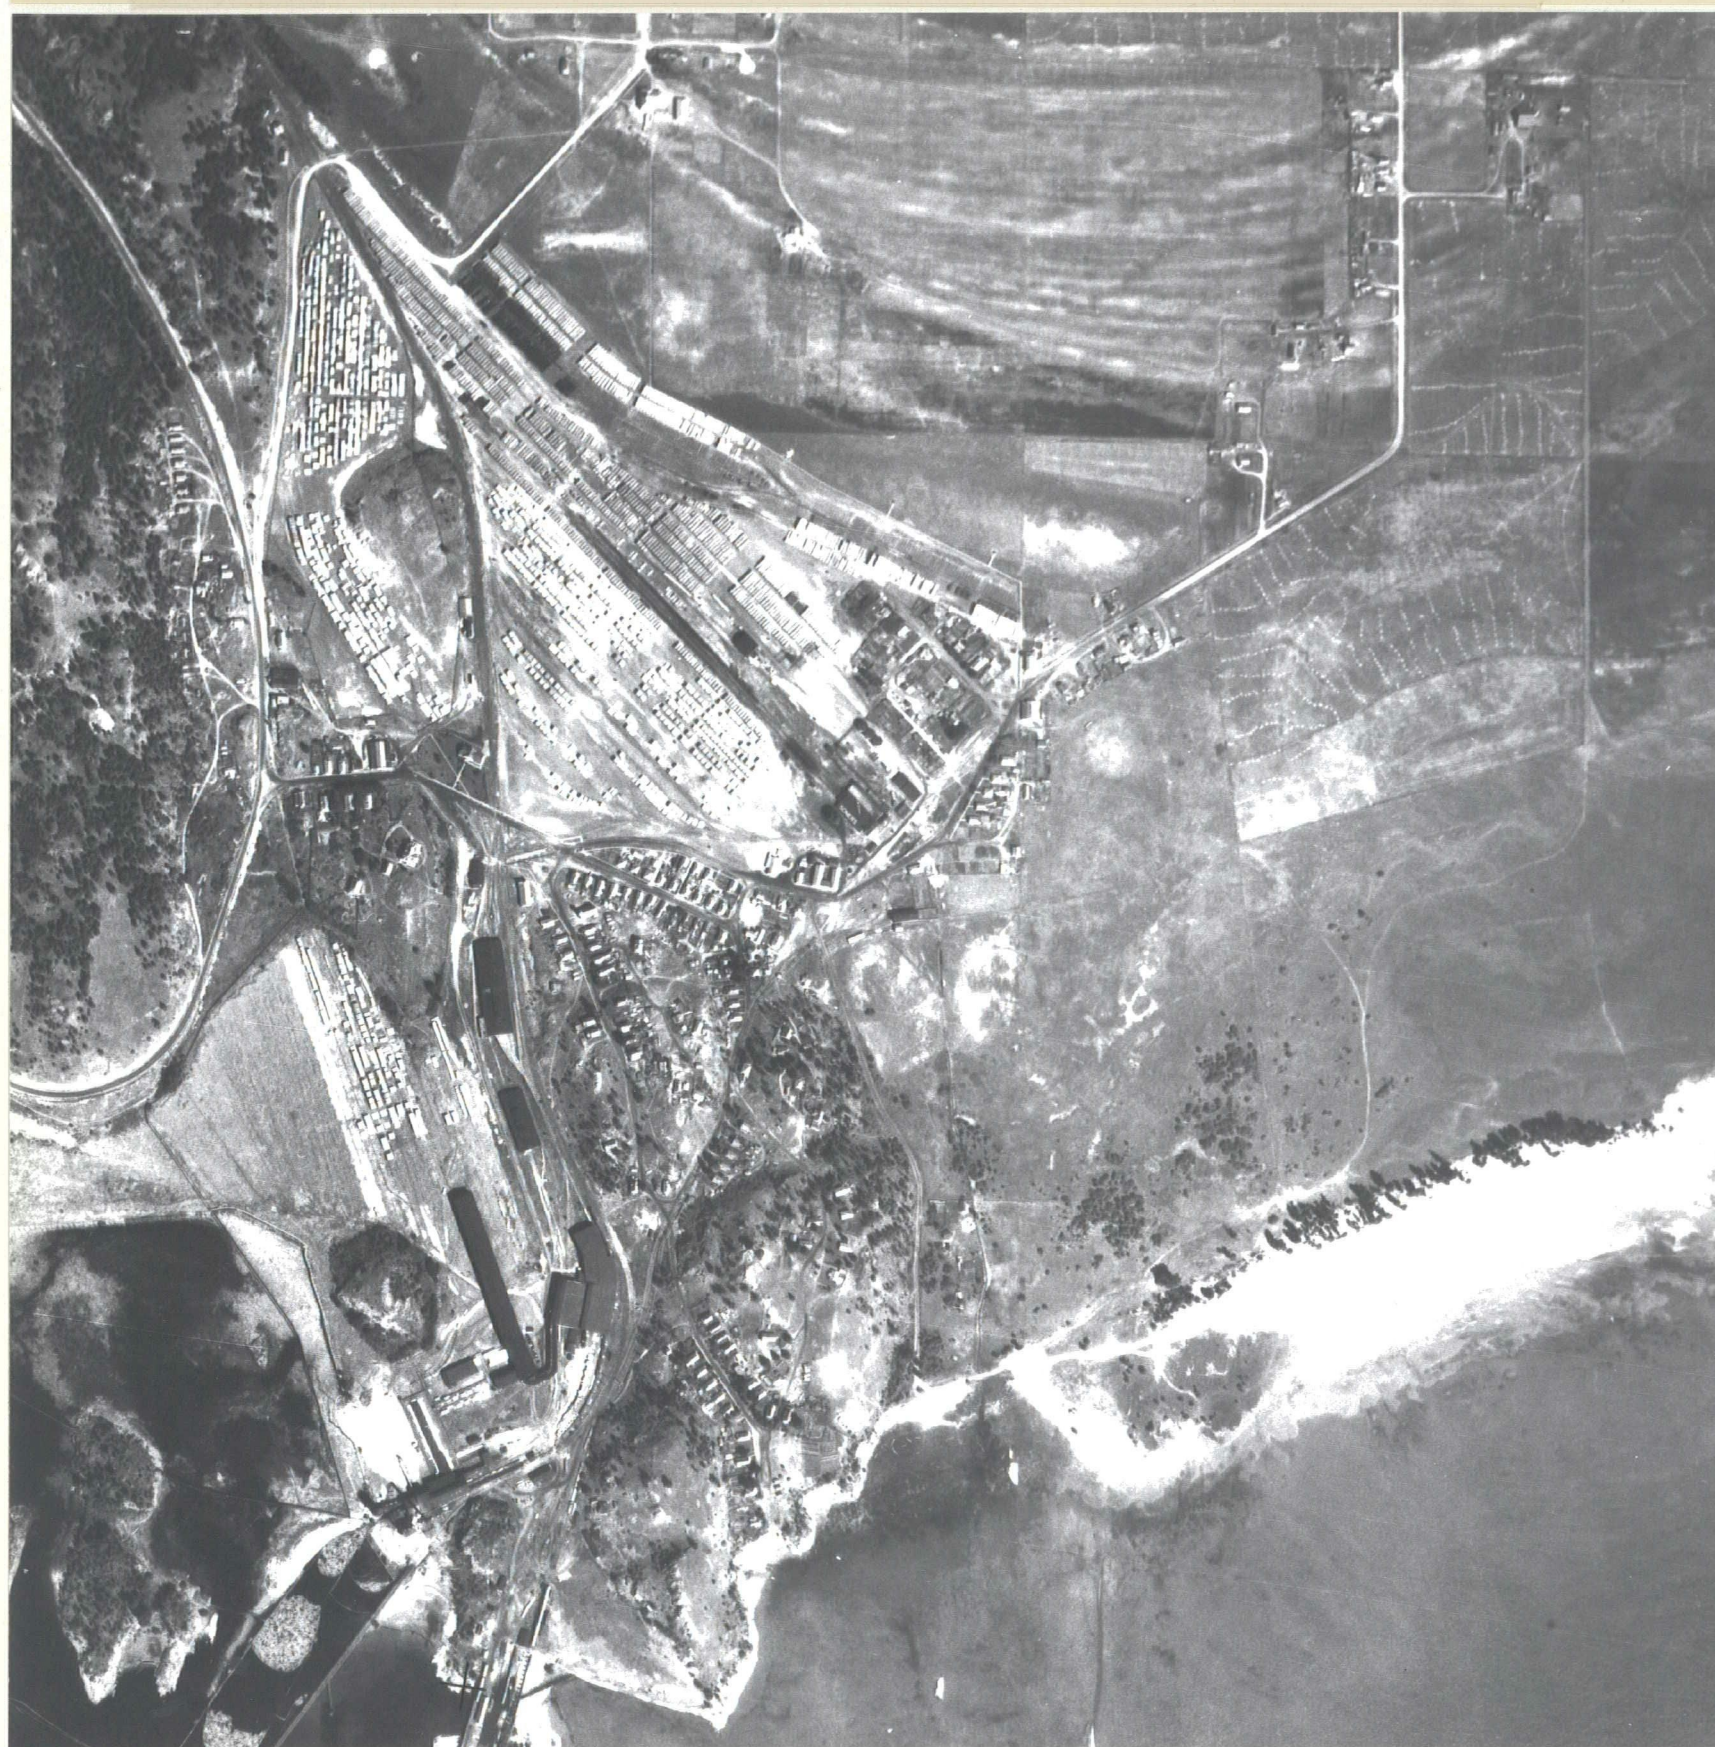
Figure 3. Burlington Northern Railroad, Somers Tie Treatment Plant, August 16, 1937. Approximate scale 1:8,100.

The Burlington Northern Railroad, Somers Tie Treatment facility is on the north side of the community of Somers which is located on the northwest corner of Flathead Lake. The 1937 photograph (Figure 3) shows the active tie treatment plant covers approximately 82 acres. The site is in the Flathead River Valley which extends north. The facility is constructed on alluvial deposits and is adjacent to terrain depression of an old oxbow lake. Regional drainage flows southeast in this river valley into Flathead Lake. The site is constructed on nearly level ground; however, the terrain drops off along the site's north perimeter into the adjacent terrain depression of an old oxbow lake (annotation "A"). The cut lumber used for railroad ties arrives at the facility from a sawmill located approximately one-half mile away on the north shore of Flathead Lake. The wood treatment facility contains processing buildings and three vertical storage tanks near its southeast corner (annotation "B"). Drip tracks (annotation "C") are visible leading into the tie treatment building and are identified by the associated dark ground stains.

Most of the area of this facility is open storage yards containing treated and untreated wood railroad ties. Spillage of creosote or other tie treating compounds appears to flow southeast, downslope, into a terrain depression on the south side of the tie treatment building (annotation "D"). A shallow drainage ditch (annotation "E") starts outside of the tie treatment site and channels runoff to Flathead Lake. There are no visible drainage channels that link this ditch to the wood treatment facility.

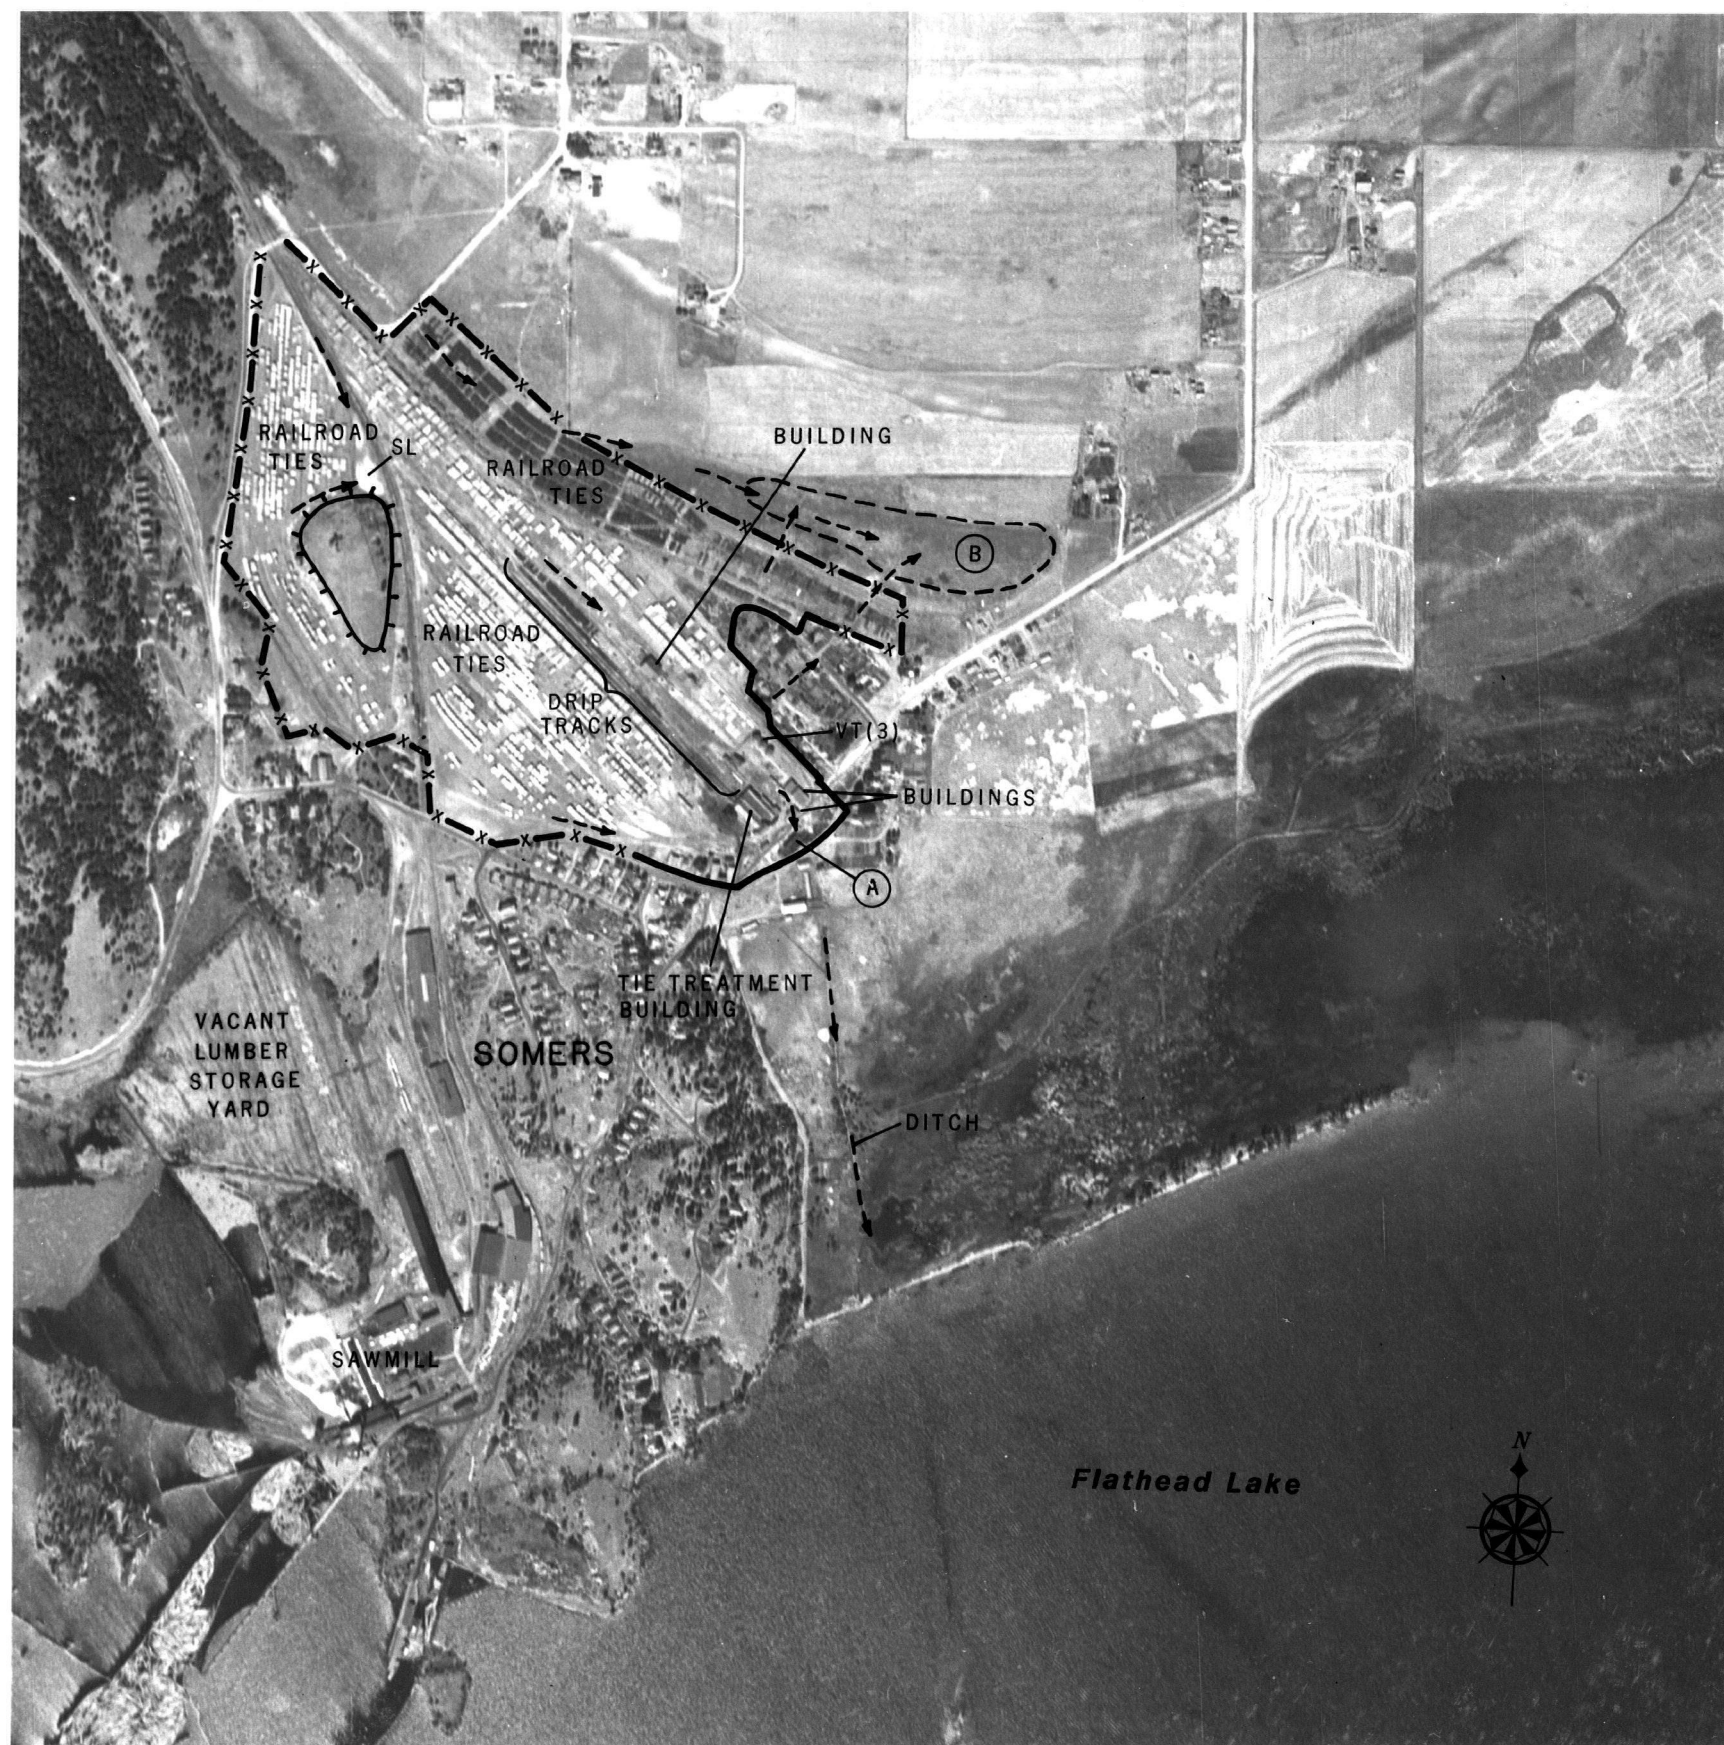
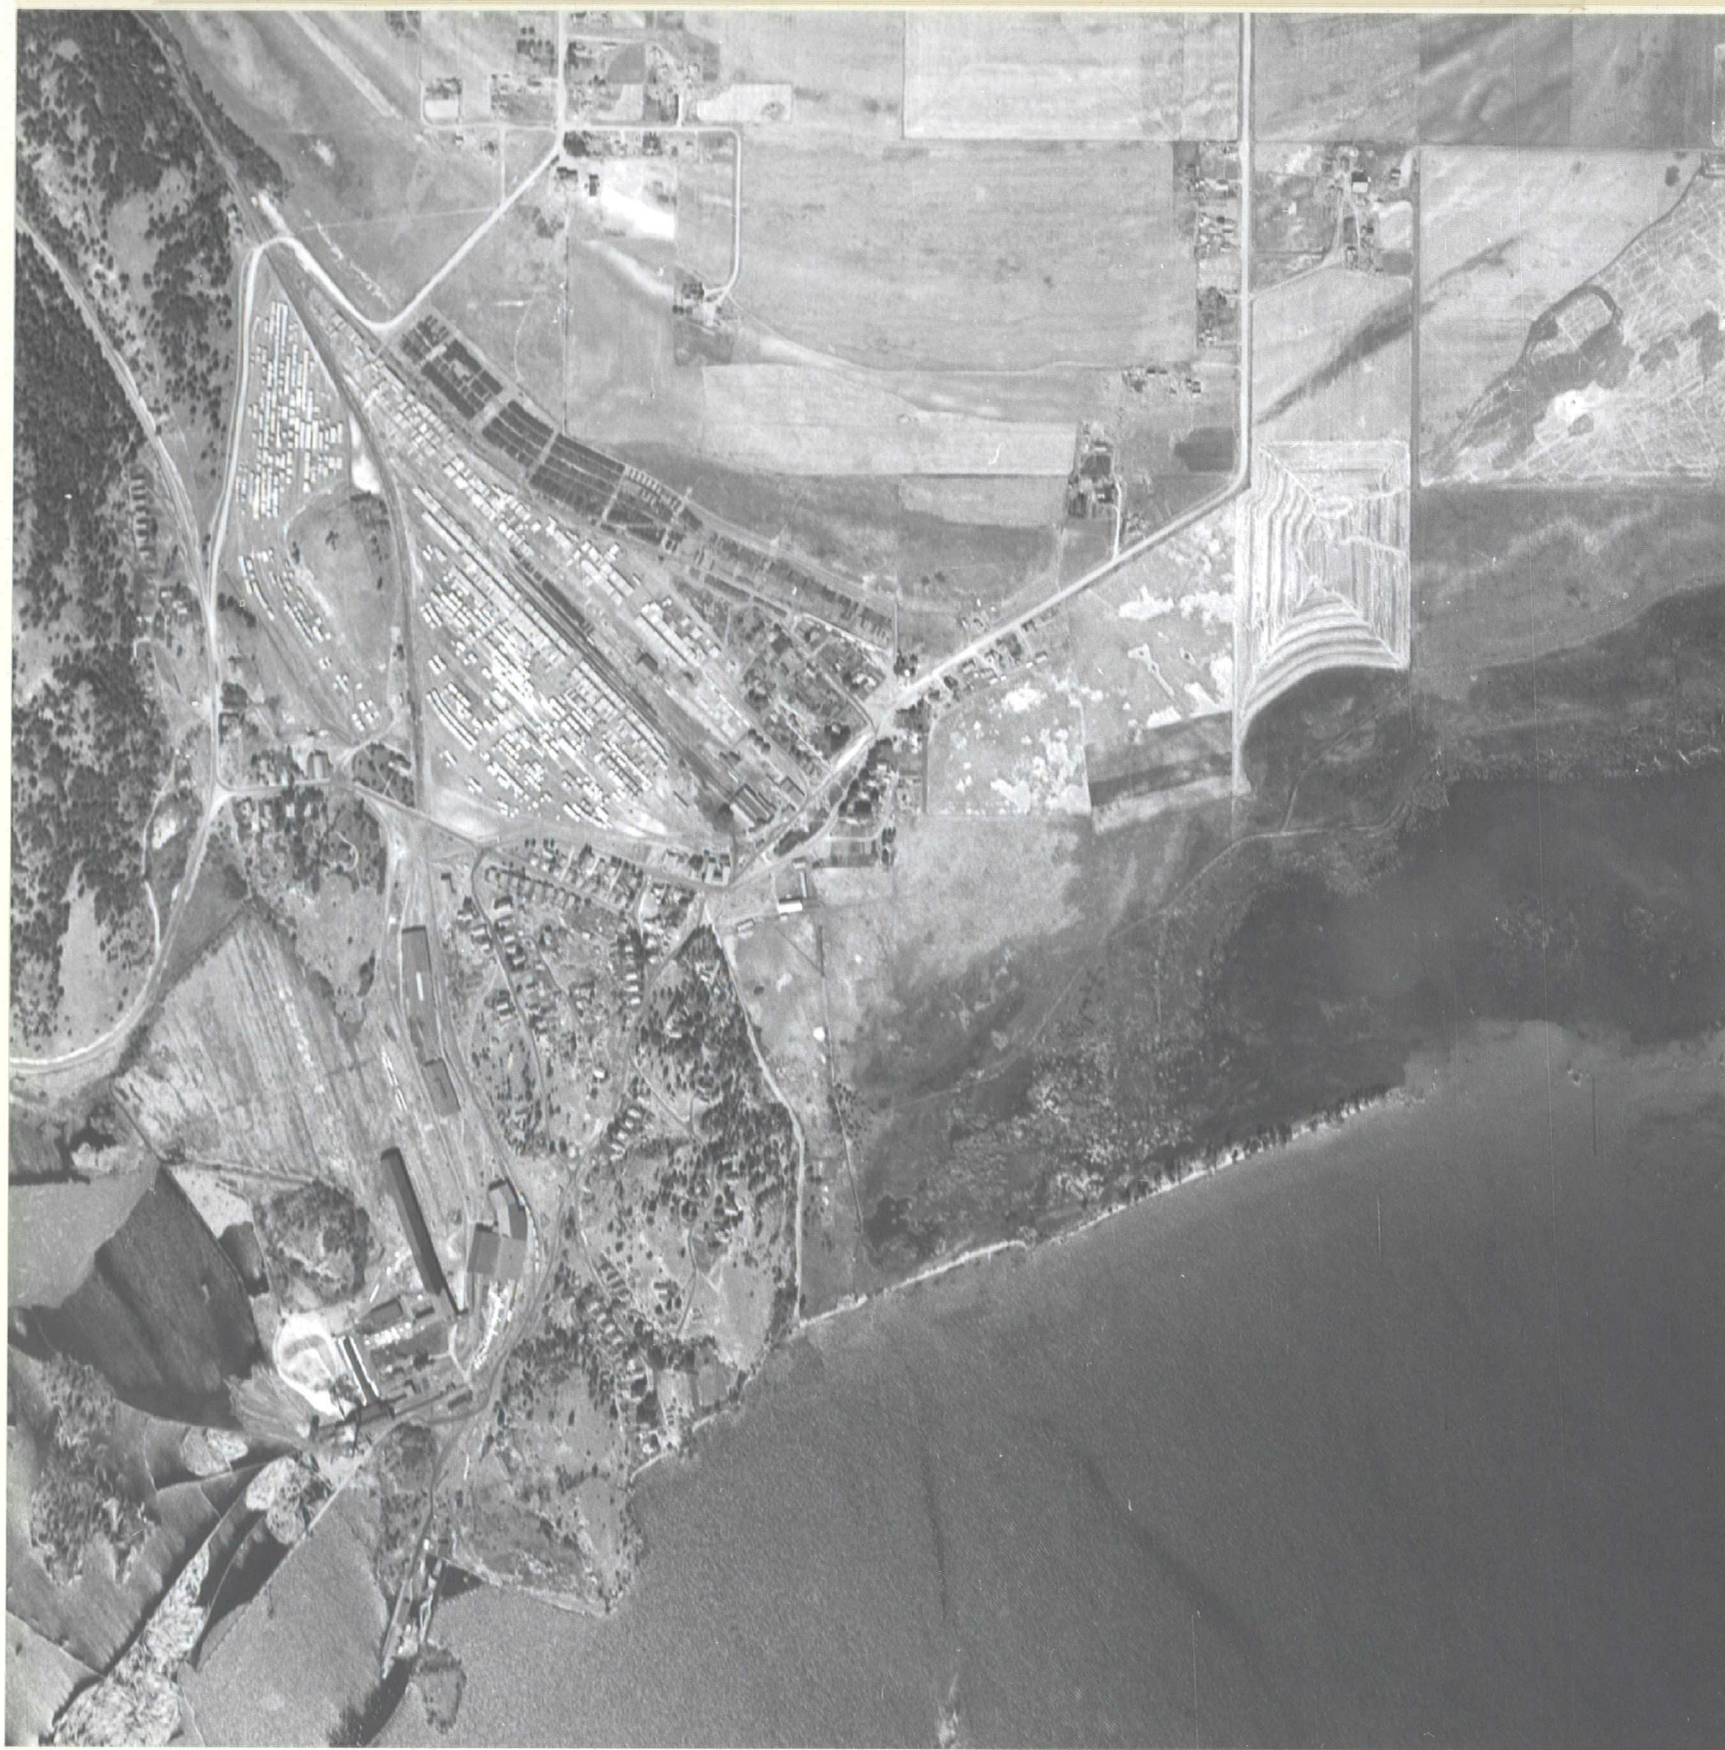
Figure 4. Burlington Northern Railroad, Somers Tie Treatment Plant, August 18, 1946. Approximate scale 1:9,000.

The 1946 photograph (Figure 4) shows the wood treatment plant is operational and its open storage yards contain numerous stacks of railroad ties. There are no significant changes at this site since 1937 (Figure 3). The saw mill southwest of the tie treatment facility is also active.

Surface drainage patterns appear unchanged from the 1937 photograph. The drainage from the south end on the facility appears to enter a terrain depression (annotation "A") while drainage from the north portion of the site enters a terrain depression of an old oxbow lake (annotation "B"). There is no discernable indication of leachate or vegetation stress.

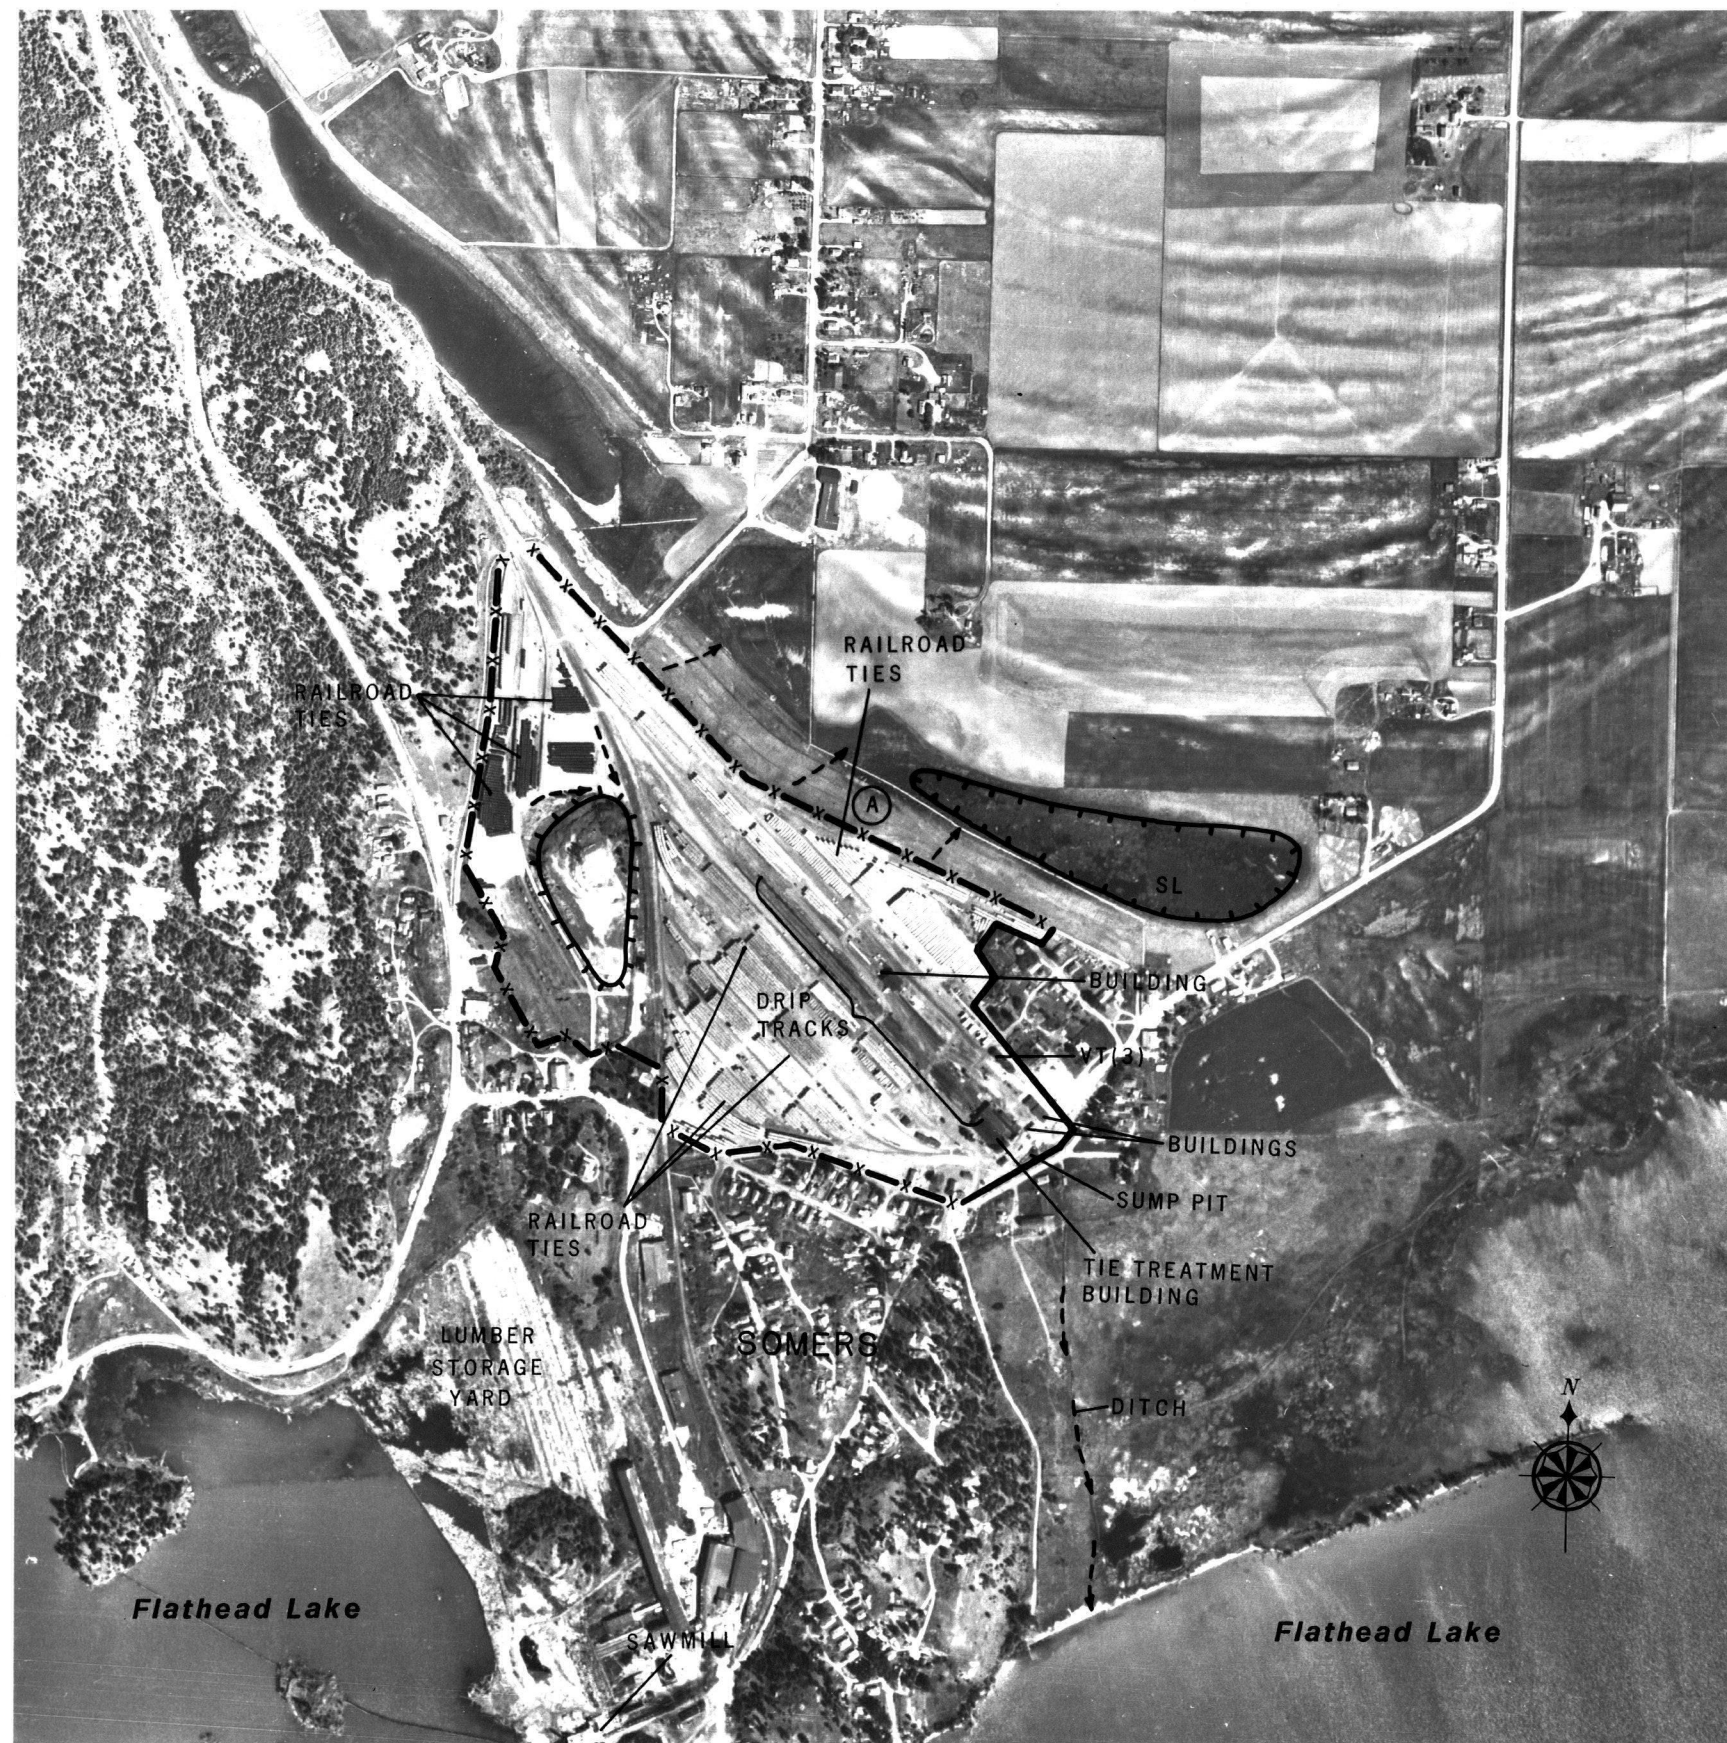
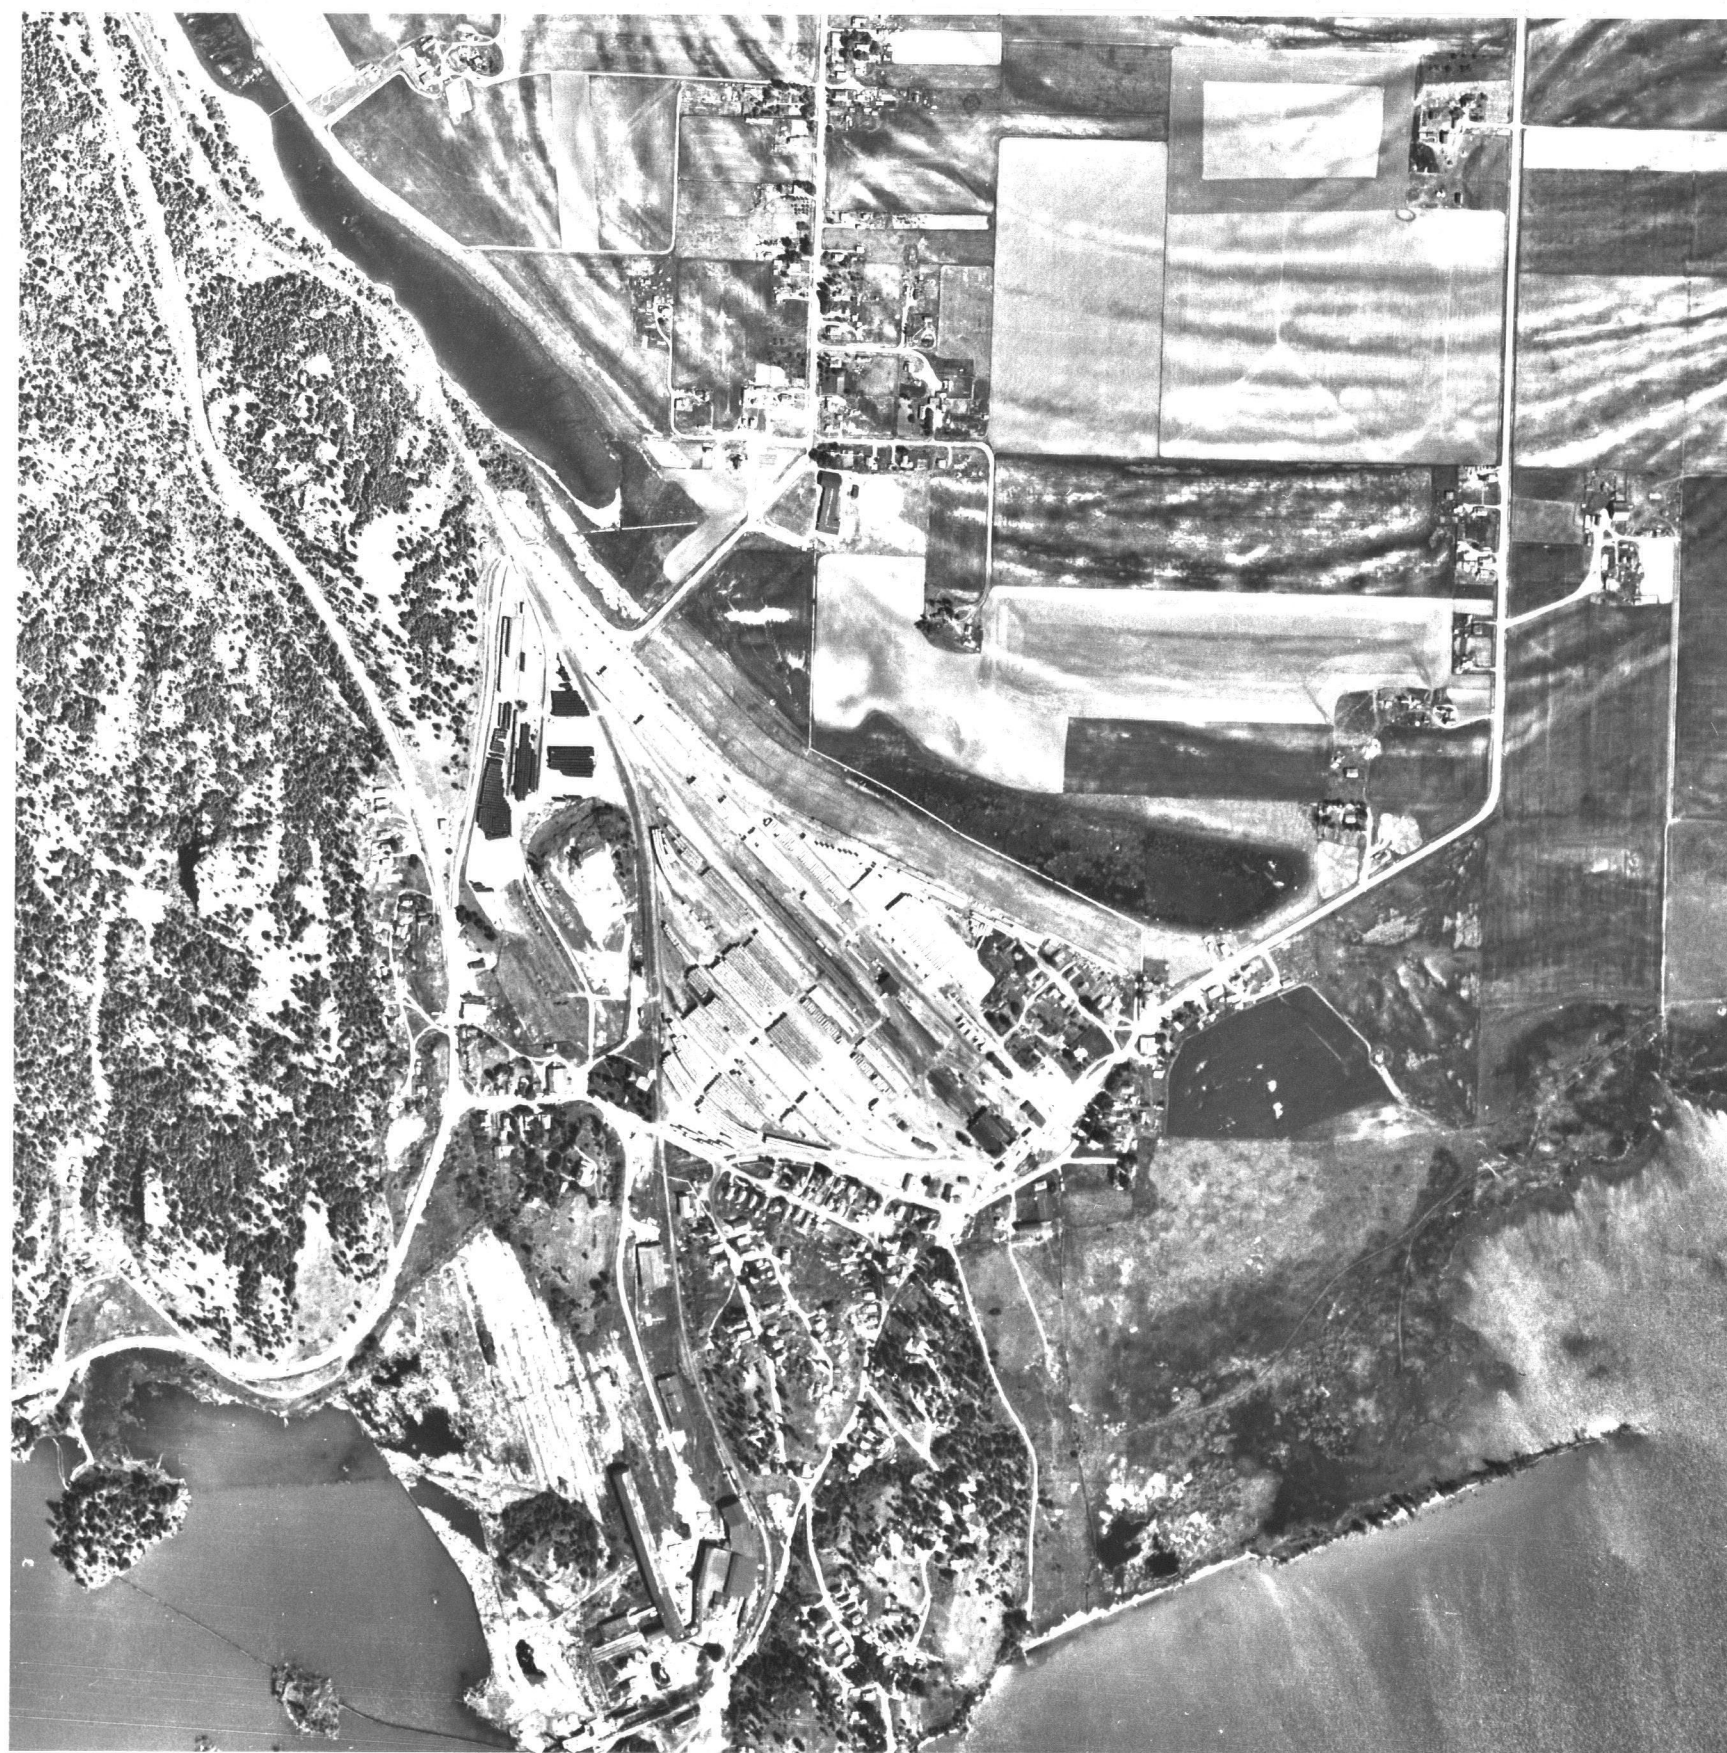
Figure 5. Burlington Northern Railroad, Somers Tie Treatment Plant, July 13, 1954.
Approximate scale 1:9,000.

The 1954 photograph (Figure 5) reveals an operational wood treatment plant with numerous stacks of railroad ties in its open storage yards. It is likely the dark-toned stacks in the northwest portion of the facility are treated while the lighter-toned stacks have not been treated. There has been little change at this plant since 1937 (Figure 3); one observed difference is the emptying of the storage yard along the site's northeast side (annotation "A") and the inward movement of the perimeter fence.

The sawmill southwest of the wood treatment plant has less lumber in its adjacent lumber storage yards. This sawmill could be closed down.

Surface drainage from the vacated storage yard of the wood treatment plant flows into the adjacent oxbow lake. Runoff from the tie treatment area is now apparently retained in a sump pit where a terrain depression had previously collected runoff. No drainageways are visible that link this sump pit to a drainage ditch leading into Flathead Lake. There are no discernable signs of leachate or vegetation stress associated with operations at this site.
